Manhole Inspection Summary

Manhole # S19AA_012MH

Insp Date: **10/30/07 9:30 AM**

Location Address: **800 PULASKI-BRICE**

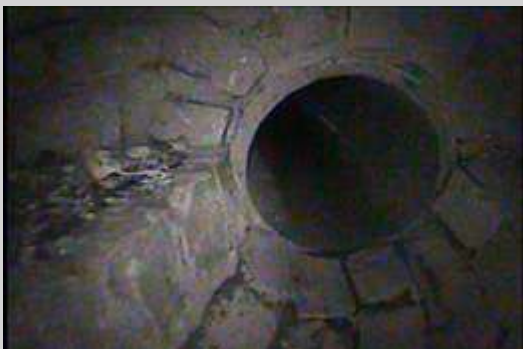
3 O'Clock Inflow

8 in. Circular Gravity Sewer
Pipe In @ 3 O'Clock

Pipe Height: **8.4** (in.) Rod and Bar (Angled)
Pipe Material: **Clay** ☐ Pipe Lined
Invert Depth: **7.55** (ft.) Flow Characteristics: **Slow**
Deposits: ☒ **None** ☐ Mud ☐ Sludge ☐ Debris ☐ Grease
Silt Depth: (in.) Deposits Extent:
Infiltration: **None** Pipe Seal Cond: **Sound**

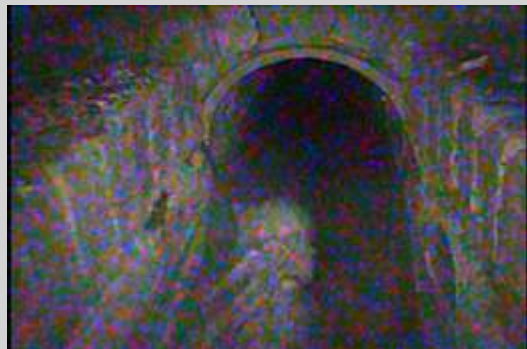
6 O'Clock Inflow

8 in. Circular Gravity Sewer
Pipe In @ 6 O'Clock

Pipe Height: **7.2** (in.) Rod and Bar (Angled)

Infiltration: **None** Pipe Seal Cond: **Sound**
